Manhole Inspection Summary

Manhole # S07YY1016MH

Insp Date: **9/20/06 1:23 PM**

Location Address: **2900 GLEN AVE**

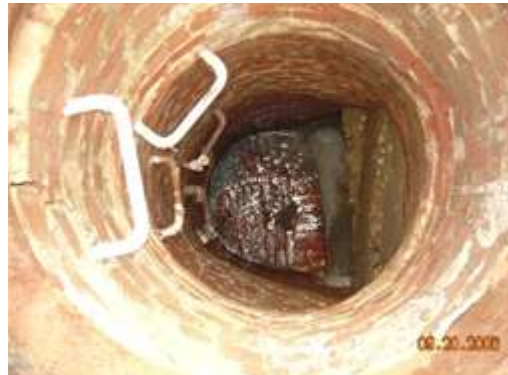
Top View

Frame leaks. Adjustment and Corbel deterioration and infiltration. Barrel infiltration.

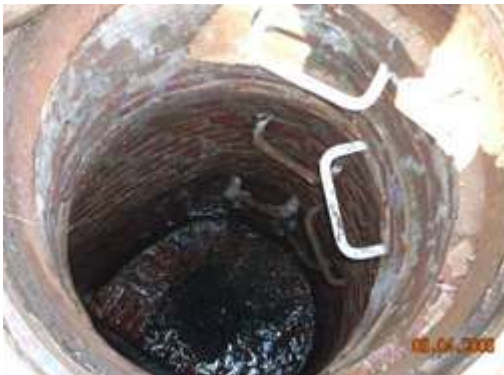
Defect

Frame leaks. Frame offset. Adjustment deterioration and infiltration. Corbel and Barrel infiltration - other side.

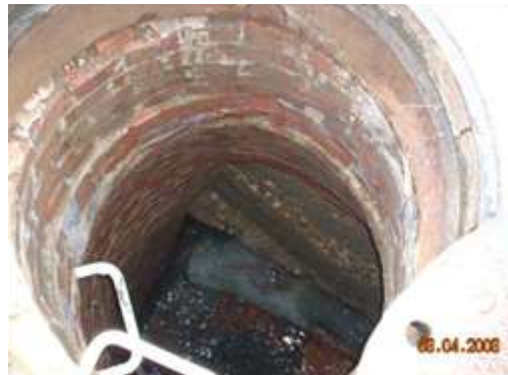
Defect

Frame leaks. Frame offset. Adjustment deterioration and infiltration. Corbel and Barrel infiltration.

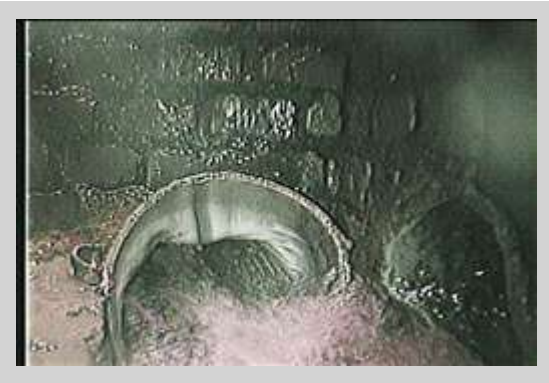
12 in. Circular Gravity Sewer Pipe Out @ 12 O'Clock

Barrel deterioration and infiltration.

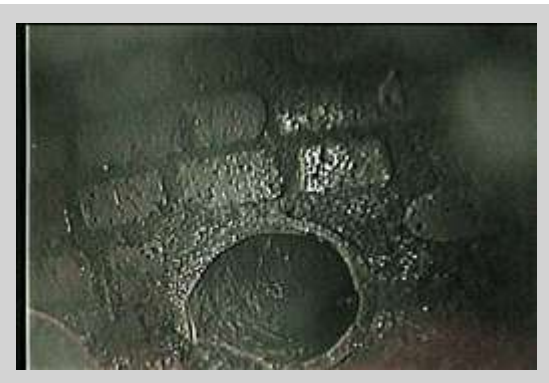
8 in. Circular Gravity Sewer Pipe In @ 2 O'Clock

Pipe Material: **Clay** ☐ Pipe Lined

Invert Depth: **9.56** (ft.) Flow Characteristics: **None**

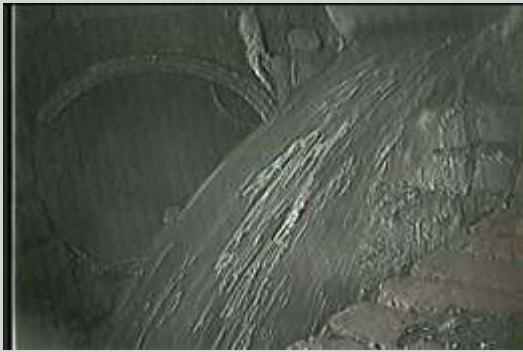
Pipe In @ 6 O'Clock

Pipe Material: **Clay** ☐ Pipe Lined

Invert Depth: **7.86** (ft.) Flow Characteristics: **None**

Infiltration: **None** Pipe Seal Cond: **Sound**

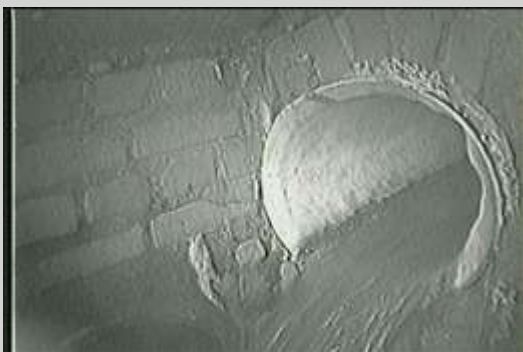
Pipe In @ 7 O'Clock

Pipe Material: **Unknown** ☒ Pipe Lined

Invert Depth: **6.26** (ft.) Flow Characteristics: **Fast**
